## **Appendix 2: Photographic evidence of work – Oxford House in Bethnal Green**

The Heritage at Risk Projects Officer visited site on several occasions during the work on site, with the last visit on 16 May 2019. The photographs below are taken during or at completion of the roof works and repairs to high level windows between January and May 2019. The work has been found to be of a satisfactory conservation standard. Some work still continues on site until the end of June 2019, but this is work which is not contained within the Historic Buildings Grant application. This includes a new entrance to the south elevation onto Weavers Fields and a new café on the ground floor.

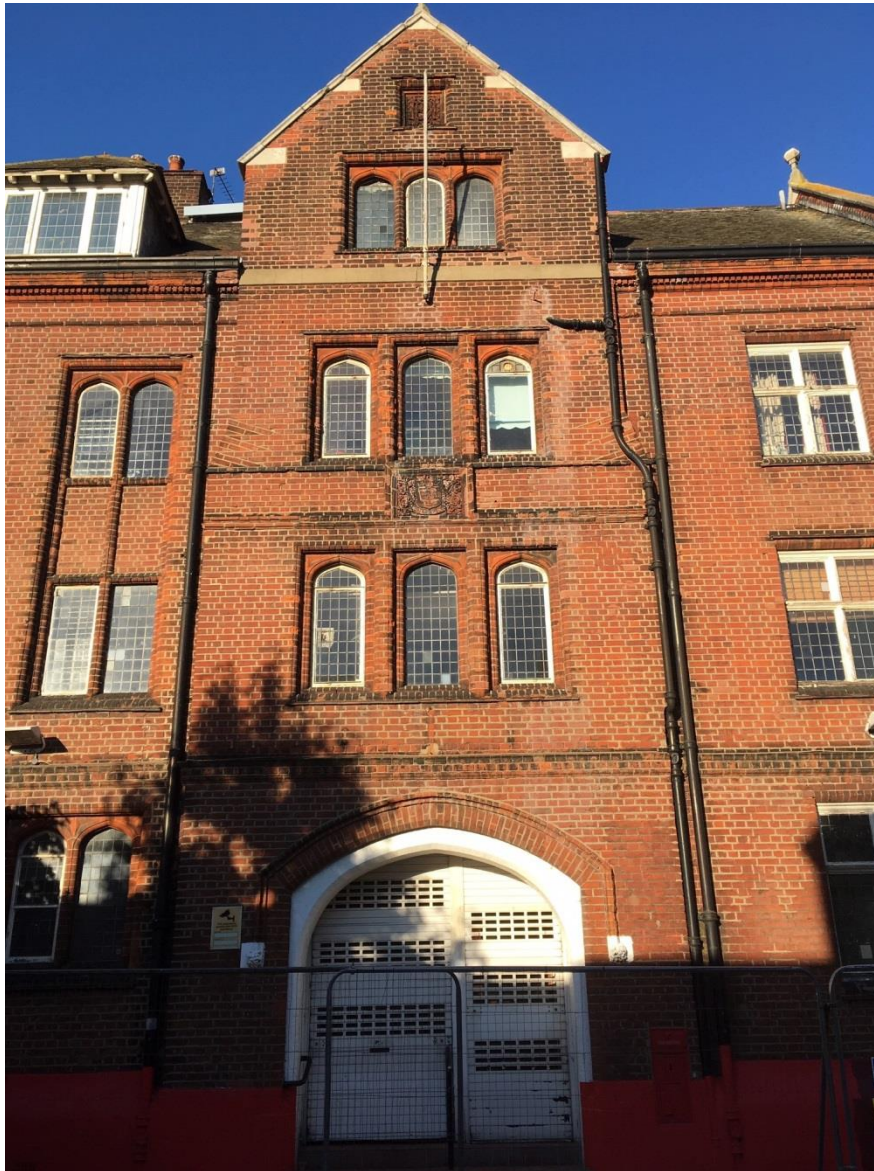
**Figure 1: West Elevation and original front entrance before work commencement**

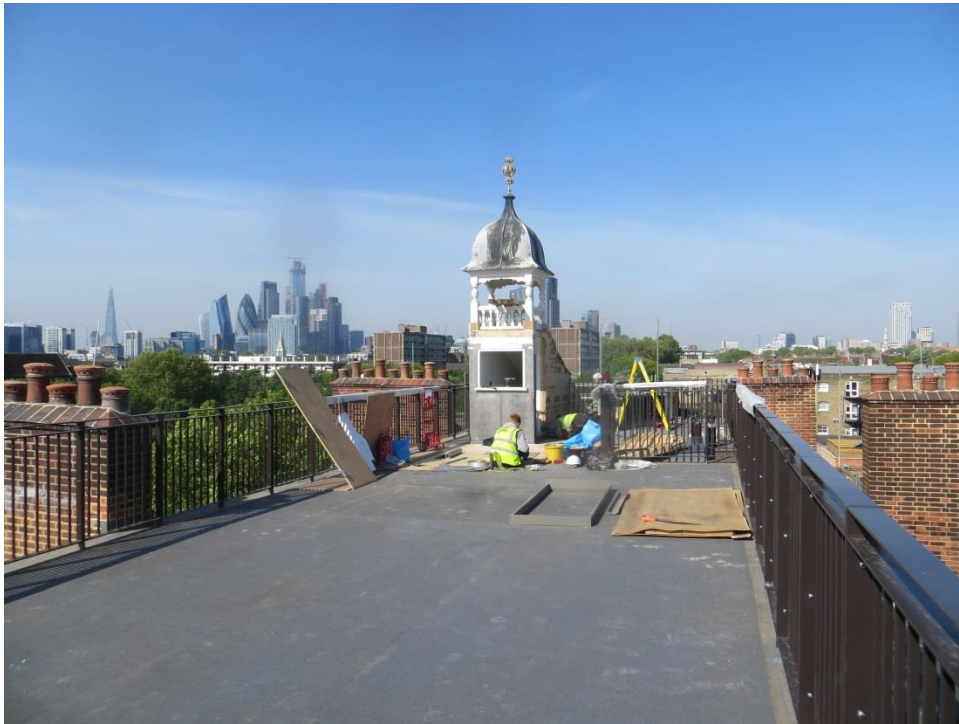
The flat roof is the roof of the chapel, considered to be one of the most significant elements of the building and an area that was suffering from significant water ingress with resulting damage to the historic interior. Less than 50% of the upper floor had been accessible to the public. Historic England provided a grant in 2016 to pay for some emergency roofing repairs and a tin hat roof. Additional work that currently continues until mid-June is the cleaning of the water-stained panelling on the interior of the chapel. Once the work is complete the chapel will finally be accessible to the public again for events, providing a revenue stream for Oxford House. The flat roof will also be accessible to the public again since the improvement of the roof covering, reinstatement of the historic balustrade and the raising of the height of the cupola to allow access. In the photo, some work is still being carried out to the cupola, and is due for completion by the end of June 2019.

**Figure 2: May 2019, flat roof looking west**

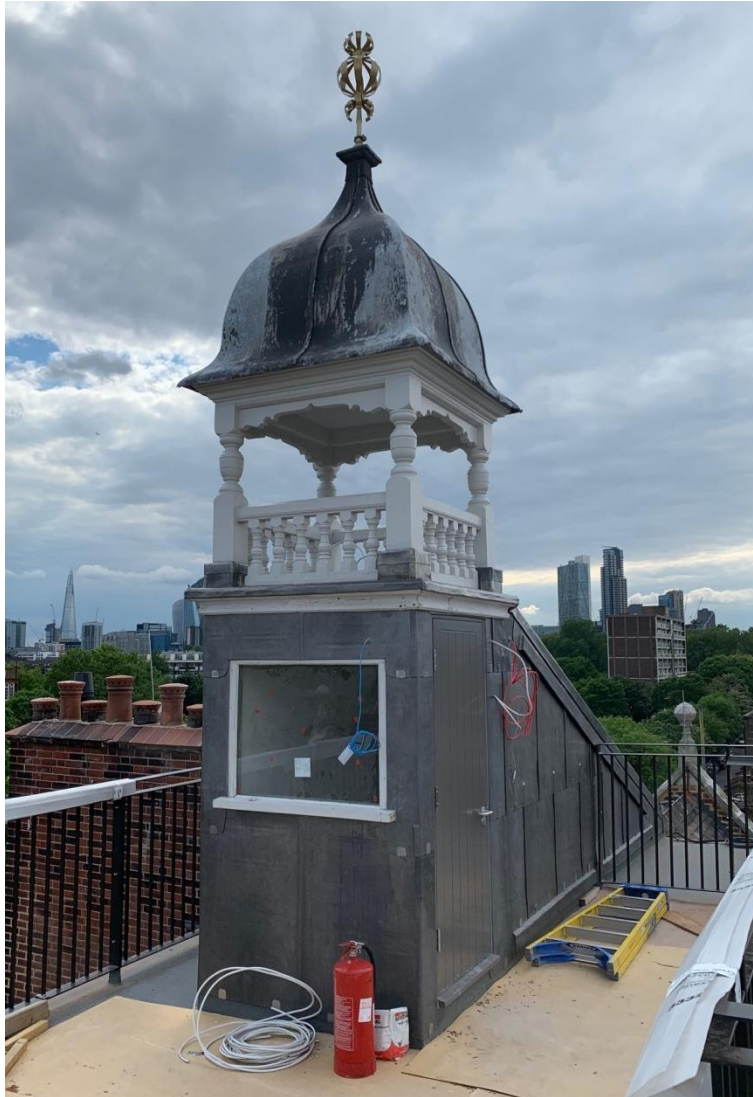
**Figure 3: May 2019, the refurbished cupola**

The height of the cupola has been raised to allow for access to the roof. The leadwork has been repaired and joinery painted.

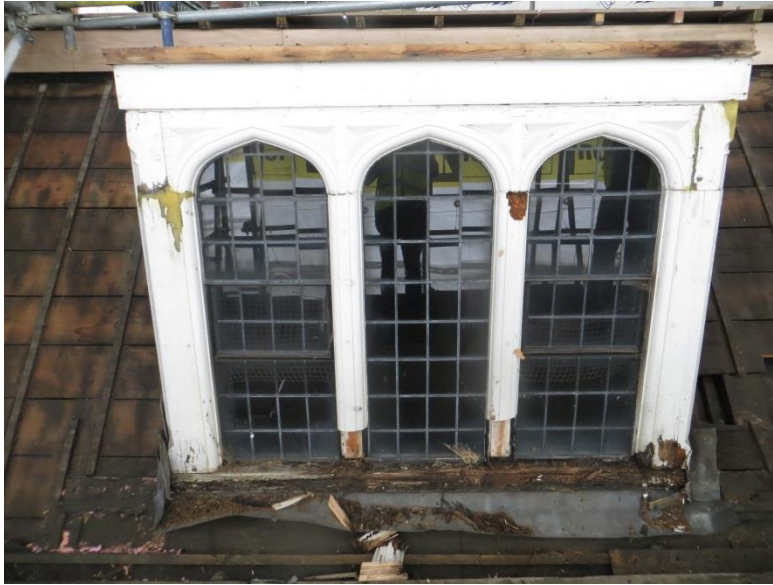
Once the scaffolding had been erected, the architects were able to make a closer inspection of the external fabric and found that the brickwork, window timber work was in a poor condition and much worse than originally anticipated. Works were prioritised based on difficulty of access for future works and the amount of decay that had occurred. All work that was accessed by full height scaffold was prioritised – which included roof repairs and high level window repairs. It is likely that further brickwork repairs to the west elevation will be required at a future date.

Figure 4: January 2019, whilst timber repairs are being carried out

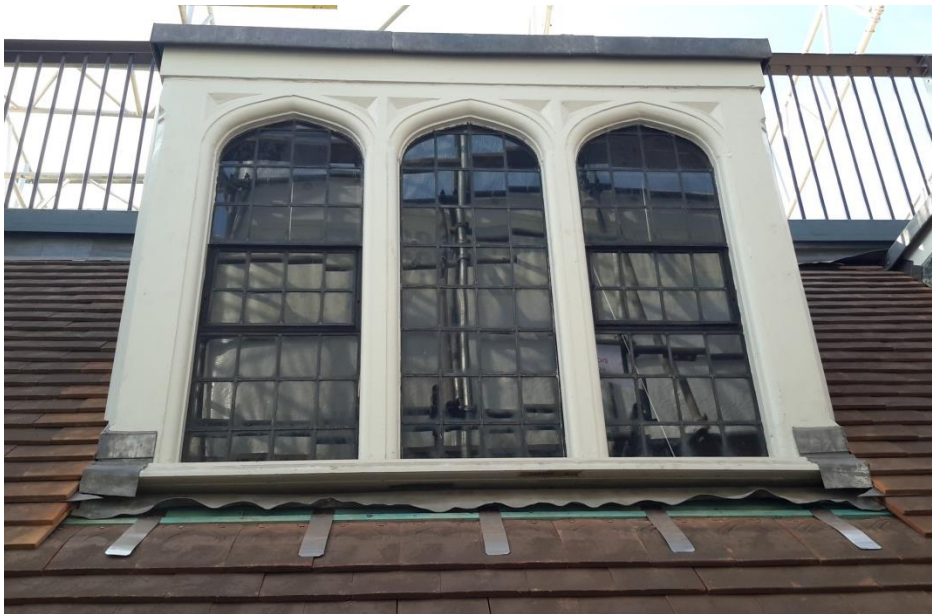
Figure 5: April 2019, after timber repairs and leadwork, final tiles still to be laid

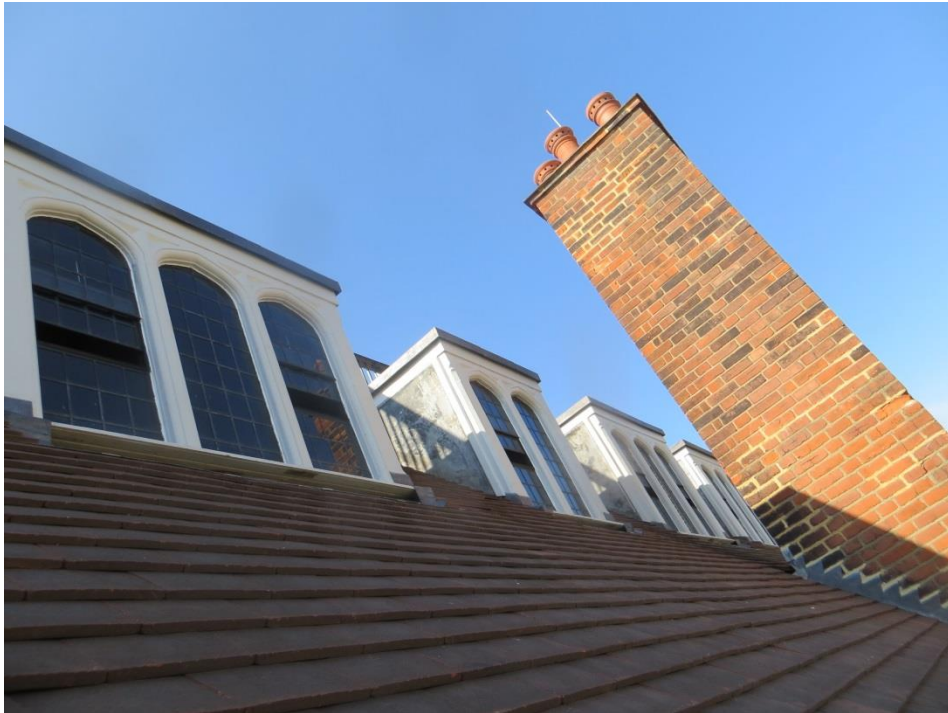
**Figure 6: View of dormers with scaffolding removed**

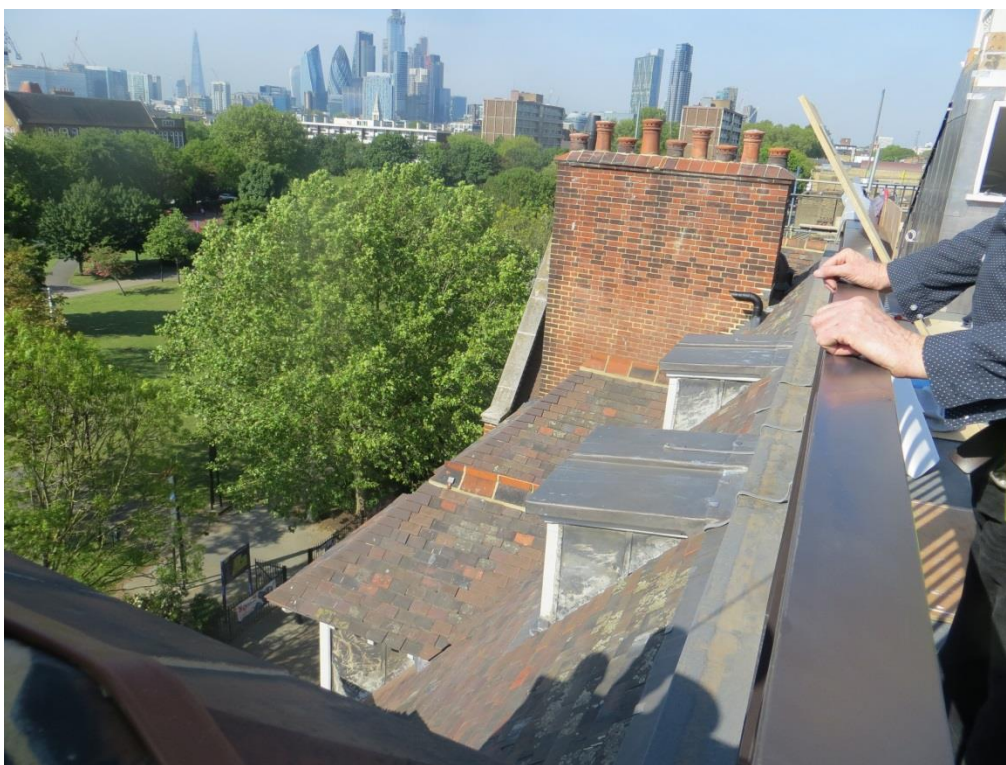
**Figure 7: Lead covering to chapel dormer windows**

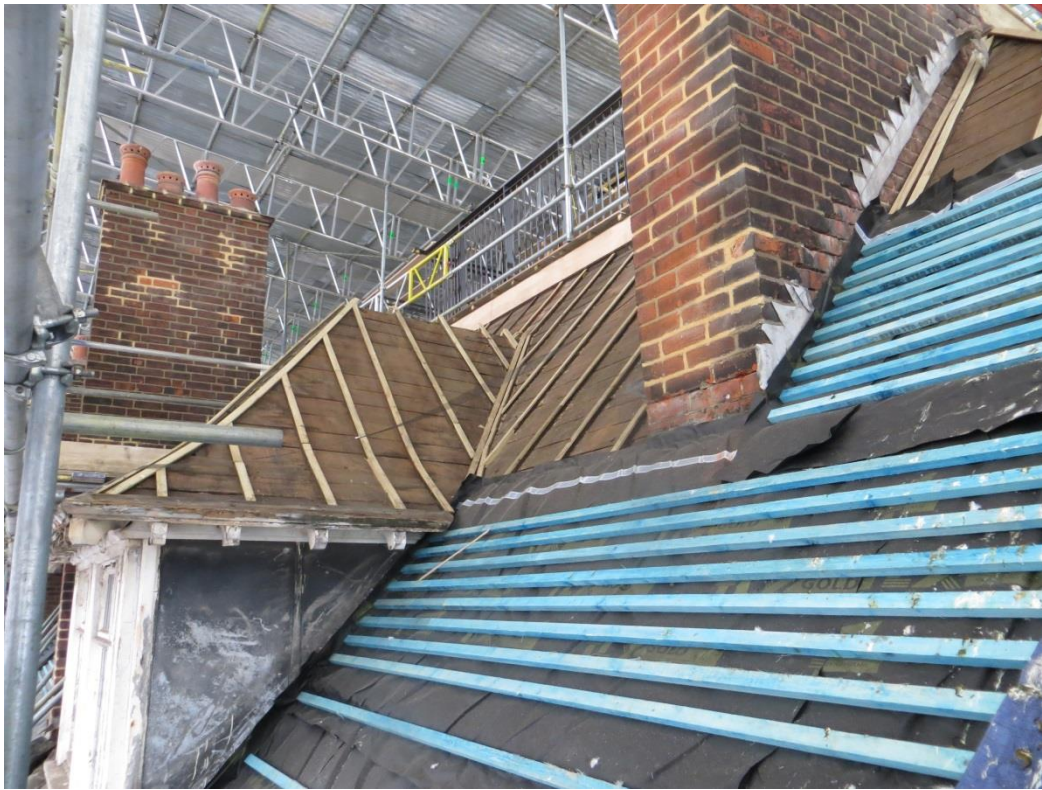
Figure 8: January 2019 - tiles were removed and as many as possible were reinstated later

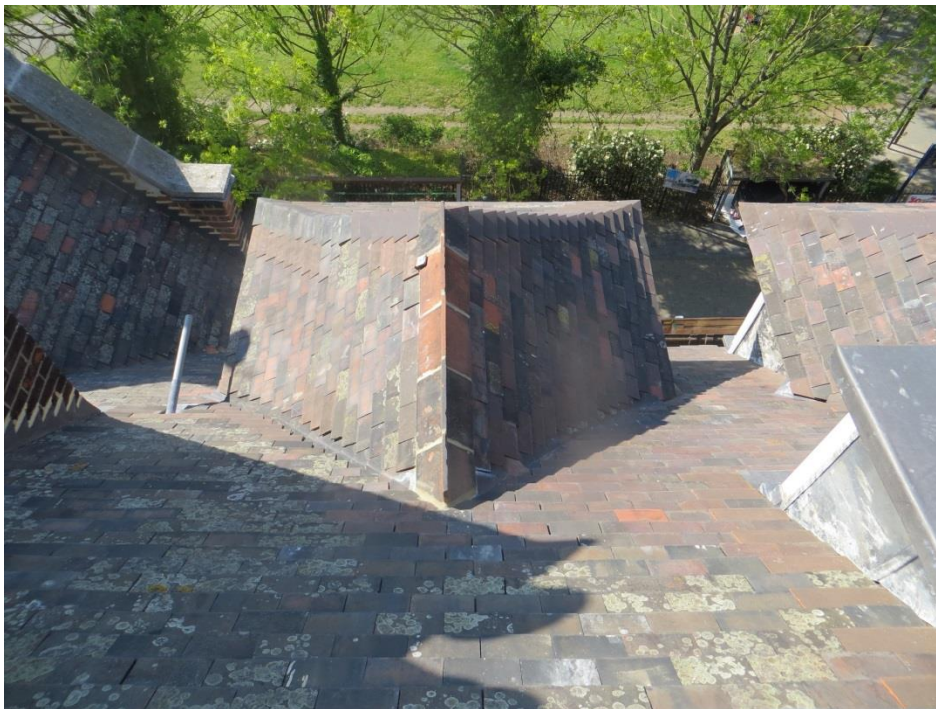
Figure 9: Retiling of high level windows

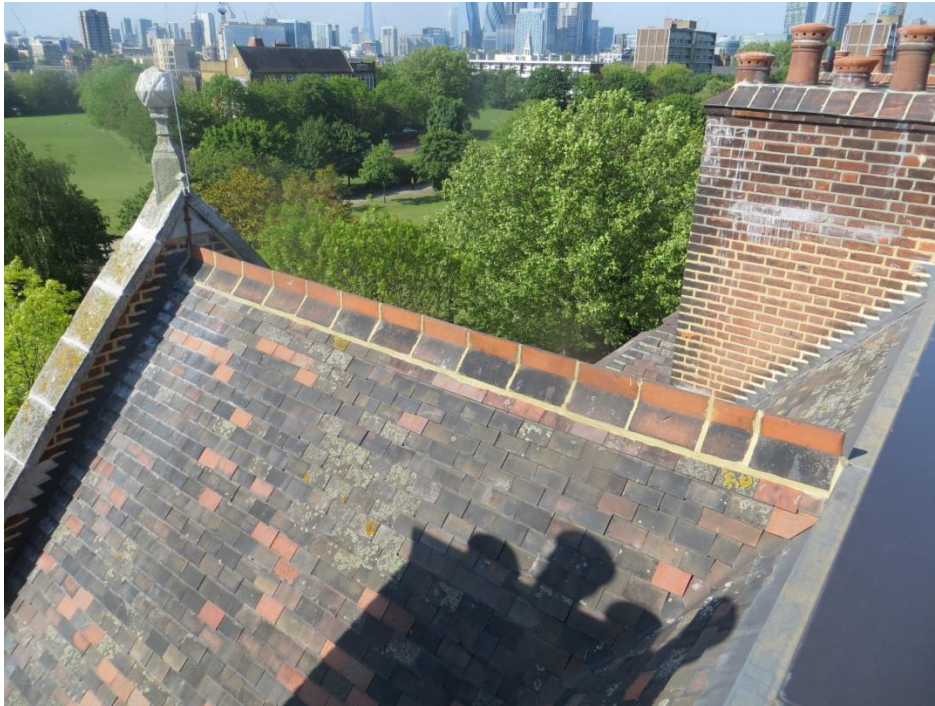
**Figure 10: Retiling of roof (see reinstated ridge tiles and fixed stone finial)**

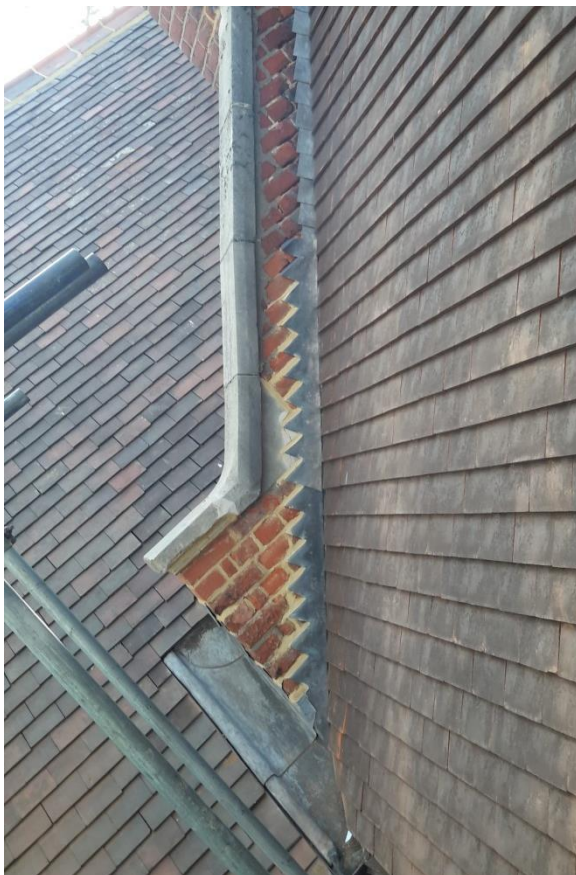
**Figure 11: Example of new lead work**
