## EXECUTIVE SUMMARY

# APPENDIX A - PRICE & MYERS STRUCTURAL REPORT

### Structural Inspection Report

Price & Myers visited St George's Leisure Centre on behalf of The Turks Head Charity (client) on 14<sup>th</sup> March, 2022. The purpose of the inspection was to review the current condition of the existing building, and to advise on its suitability for refurbishment. The areas of the building considered to be of most 'concern' were inspected. No finishes were removed, no floorboards were lifted, and no intrusive assessments were carried out. As structural engineers we are unable to advise on issues related to water ingress and building services unless there are obvious structural implications.

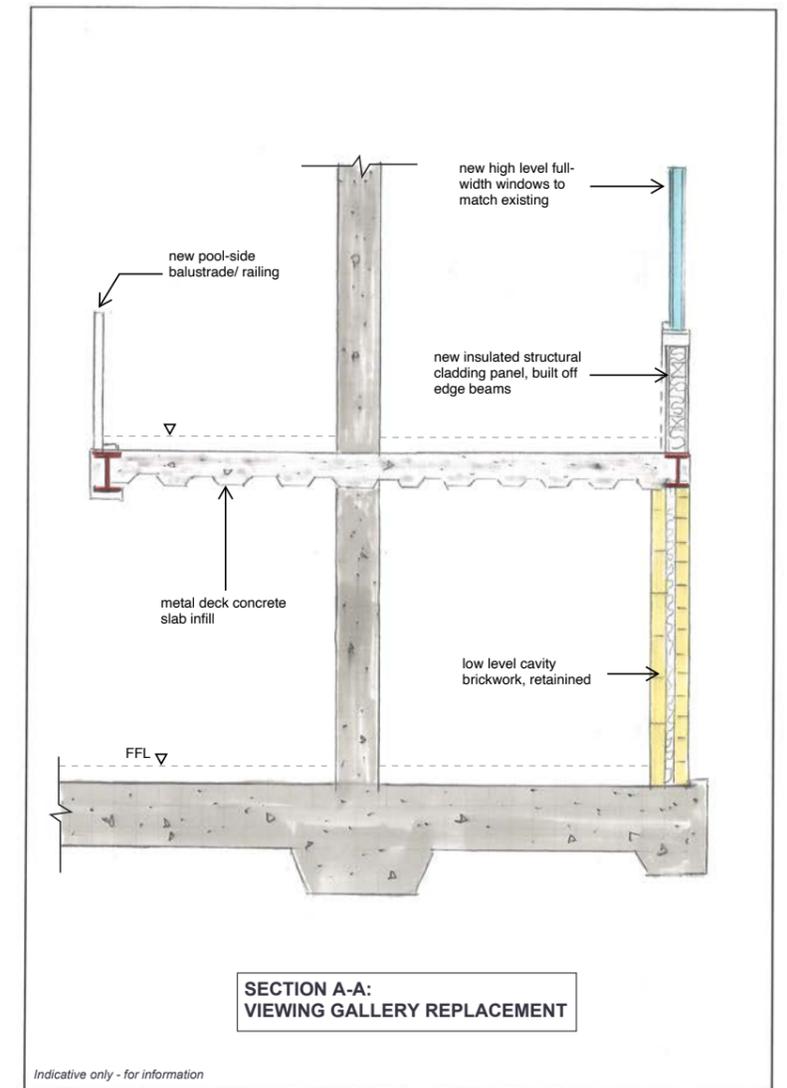
Indicative section proposing the replacement of concrete viewing galleries with metal deck filled with concrete  
Price & Myers Structural Inspection Report, Appendix A

1. strip-back to primary structure - including the removal of cladding, roof, windows and surface finishes
2. execute a detailed survey of concrete structure throughout
3. make concrete repairs locally
4. apply new specialist membrane to main pool and overlay tiles throughout
5. re-make galleries using metal deck with concrete slab infill
6. replace external envelope on gallery floors

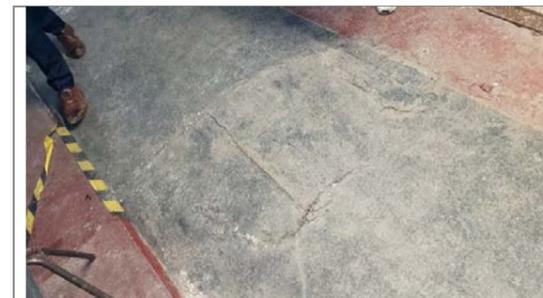
The basement floor itself was mixed in condition. There were some isolated areas where standing water had obviously caused staining to the floor. This was noticeable mostly around drainage, manhole and gully points where drainage had once backed-up. Noticeable areas of the salt/ debris deposition were also evident. Water ingress has caused surface delamination to the painted floor with some more severe areas of concrete spalling. In one particular area, the concrete surround of a manhole cover had spalled to the point where the entire section of floor had to be broken out, and replaced with a temporary metal plate. Noticeable 'bulges' in the floor were also evident. It is not clear the exact cause of this, but judging by the location, it's possible that failed drainage runs below the slab may be swelling, causing the soil under to 'lift' the slab up. The basement room itself did not feel humid nor damp, suggesting that the overall waterproofing and general low-level external envelope had not been compromised.

Figure 2 - locally damaged sections of basement floor slab requiring break-out and reinstatement

In terms of the basement floor, it would be prudent to undertake a full CCTV survey to understand the drainage layout and condition. This would help establish the cause of the uplift/ bulge in the basement slab. In terms of making good, it is advised that the entire floor is properly condition surveyed once the area is stripped out of plant equipment. Areas of locally cracked concrete can be repaired using a repair/ coating system. Corroded elements of rebar can be repaired by wire brushing, to remove delaminated rust layer, and protected using a blackjacket paint coating. More damaged sections of the floor may need to be broken back locally and made good by resin fixing dowel bars and reinstating with new reinforced concrete.

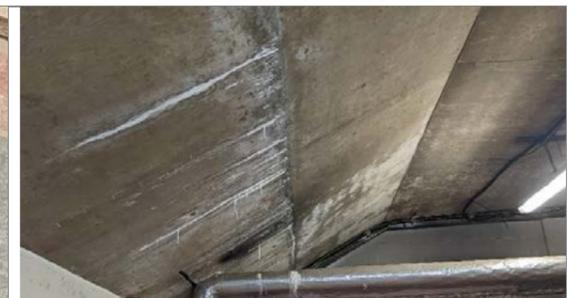
Looking at the underside of the pool box, it is clear there is some local seepage of pool water through the concrete - most likely through the original construction joints. This was most noticeable at the junction of the pool where the suspended concrete slab thickened, at a location about two thirds down its length, to accommodate the deeper section of the pool. Overall, the concrete soffit looked in good condition. There was no evidence of rebar staining or large, structurally concerning areas of spalled/ cracked concrete.

Figure 3 - seepage through concrete pool box at construction joints requiring treatment

Where the concrete pool box has failed, this can be repaired locally by injecting a waterproofing resin repair agent into the concrete to fill propagating gaps or fissures in the concrete section. A specialist will be able to advise on suitable products.

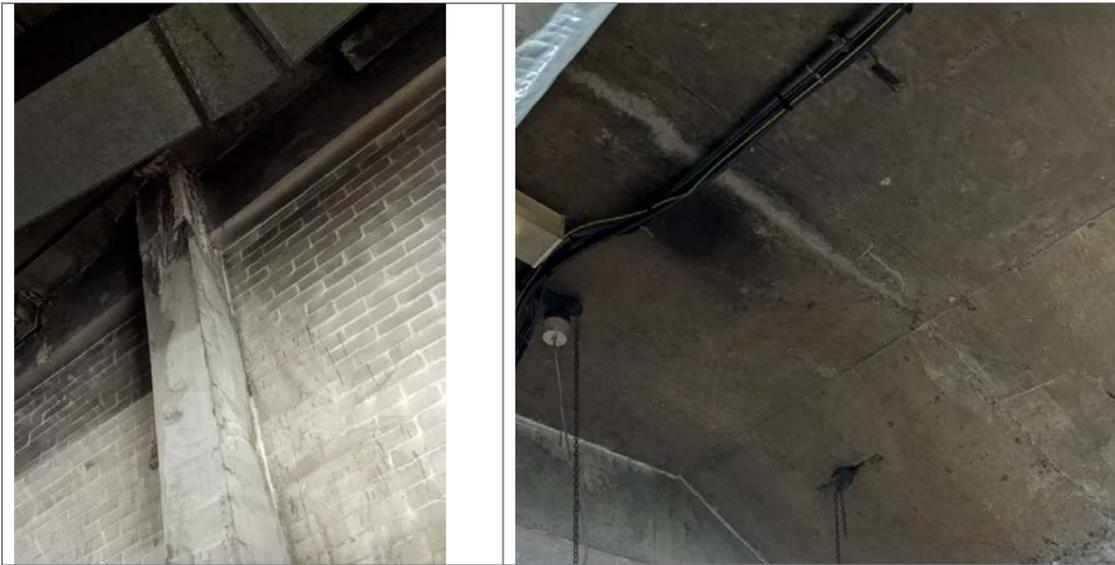
The warm environment in the plant space and the use of pool chemical treatments, has resulted in some spalling of the concrete both on soffits and in columns. Water ingress and/or chloride attack has caused the embedded rebar to rust and thus the area around to expand and burst. This combined with poor control of concrete cover leads to insufficient protection to the embedded steel and so break-off of concrete.

Figure 4 - example of previous, poorly repaired concrete column, basement level

Figure 5 - example water seepage through construction joints Combined with poorly repaired concrete slab

In the areas where concrete has spalled, this can be repaired by exposing the corroded rebar, wire-brush cleaning, and making good the surround with a repair grout/ agent. Repair work has been done in the past it seems, but the workmanship looks of poor quality where a properly bonded repair agent has not been used, resulting in further localised cracking. More specifics are raised in Chamberlain Consulting LLP report of 2018.

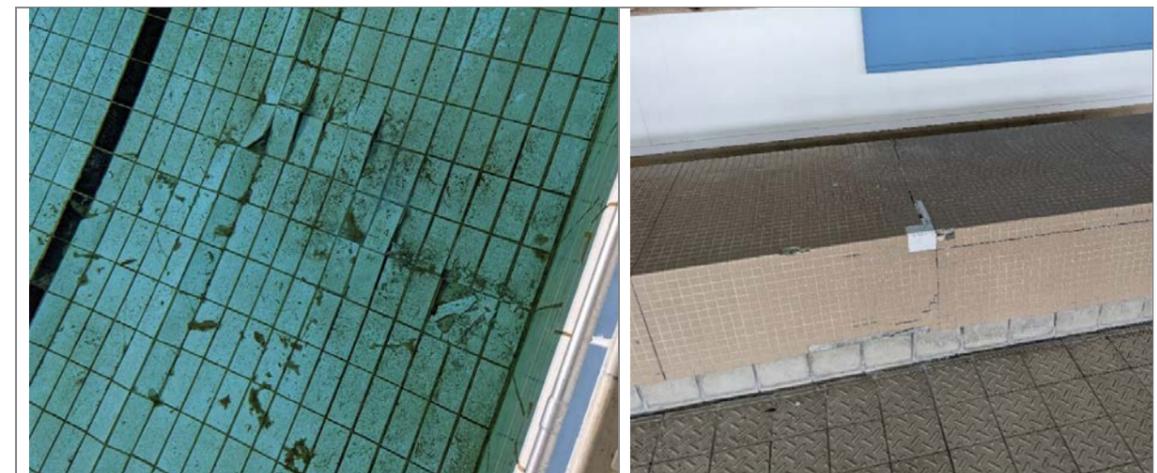
The main pool side floor area was found to be in fair condition. Structurally, there is not much to comment on, with all primary structural members effectively covered behind finishes. Some tiles were found to be cracked with individual 'shedding' of tiles evident. Cracked and lifted tiles were also seen in the pool.

The areas where the various finishes had failed was not consistent and so not thought to be part of a wider structural frame issue. More likely over time, chlorinated, or relatively damp conditions, have combined with stagnant water ingress to cause local failure of the finishes and/or backing mortar.

Figure 7 - main pool base tiles cracked/ lifted. Pool base requires local concrete repair with new membrane.

Figure 8 - mosaic tiling finishes on concrete benches cracked. Backing mortar most likely failed/ damaged behind.

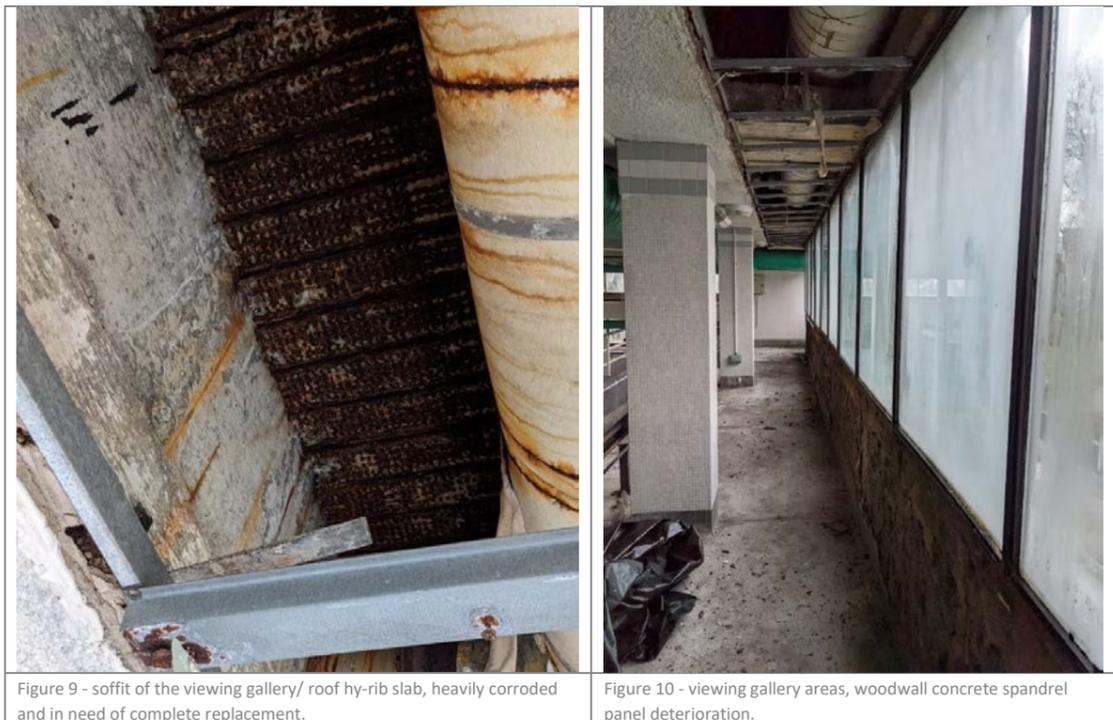
The ceilings to the higher-level viewing gallery spaces were seen to be in poor condition. Large areas were affected, most likely resulting from the humid interior environment, and/ or penetrating water through the roof above. The underside of the 'hy-rib' slabs were visible; the soffit of the trays was noticeably corroded, with local sections of concrete spalled or cracked. Where they remained, the plasterboard ceilings were sagging, presumably where water had ponded above, further emphasising that the roof locally has some leaks. This should be further investigated.

Figure 9 - soffit of the viewing gallery/ roof hy-rib slab, heavily corroded and in need of complete replacement.

Figure 10 - viewing gallery areas, woodwall concrete spandrel panel deterioration.

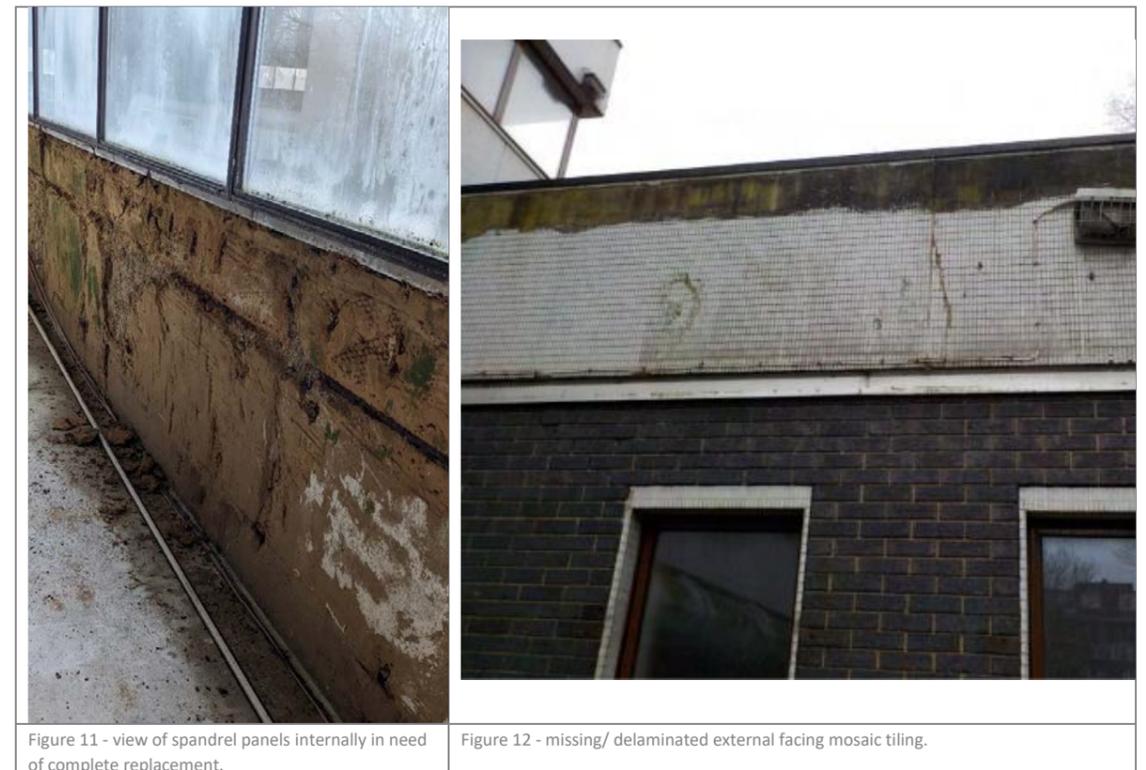
From the limited external walkaround inspection, the low-level brickwork looked in good condition with minimal signs of cracking, mortar degradation. At higher-level, the external mosaic facing tiles were seen to be 'shelling', with some individual tiles missing. This is presumably from local failure, potentially due to water ingress, damaging the backing mortar causing surface delamination. This is mostly local to areas at joints and corners where thermal and building movements occur.

Figure 11 - view of spandrel panels internally in need of complete replacement.

Figure 12 - missing/ delaminated external facing mosaic tiling.
