Structural Appraisal of

Malting and Brewster Houses,

Barley Mow Estate,  
Barleycorn Way,  
Poplar, London E14 8DE

Job No. 17:5108  
July 2018

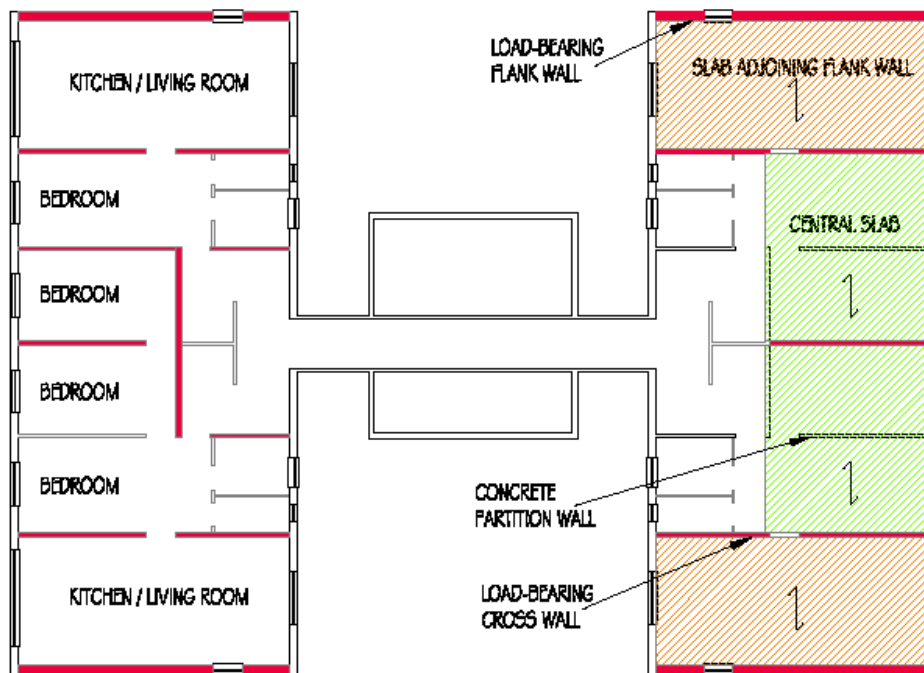
### TYPICAL FLOOR LAYOUT & CONSTRUCTION

The end or lounge slab spans from the flank wall across the Living room. The internal or central slab spans to form two bedrooms which are divided by a non-load bearing wall.

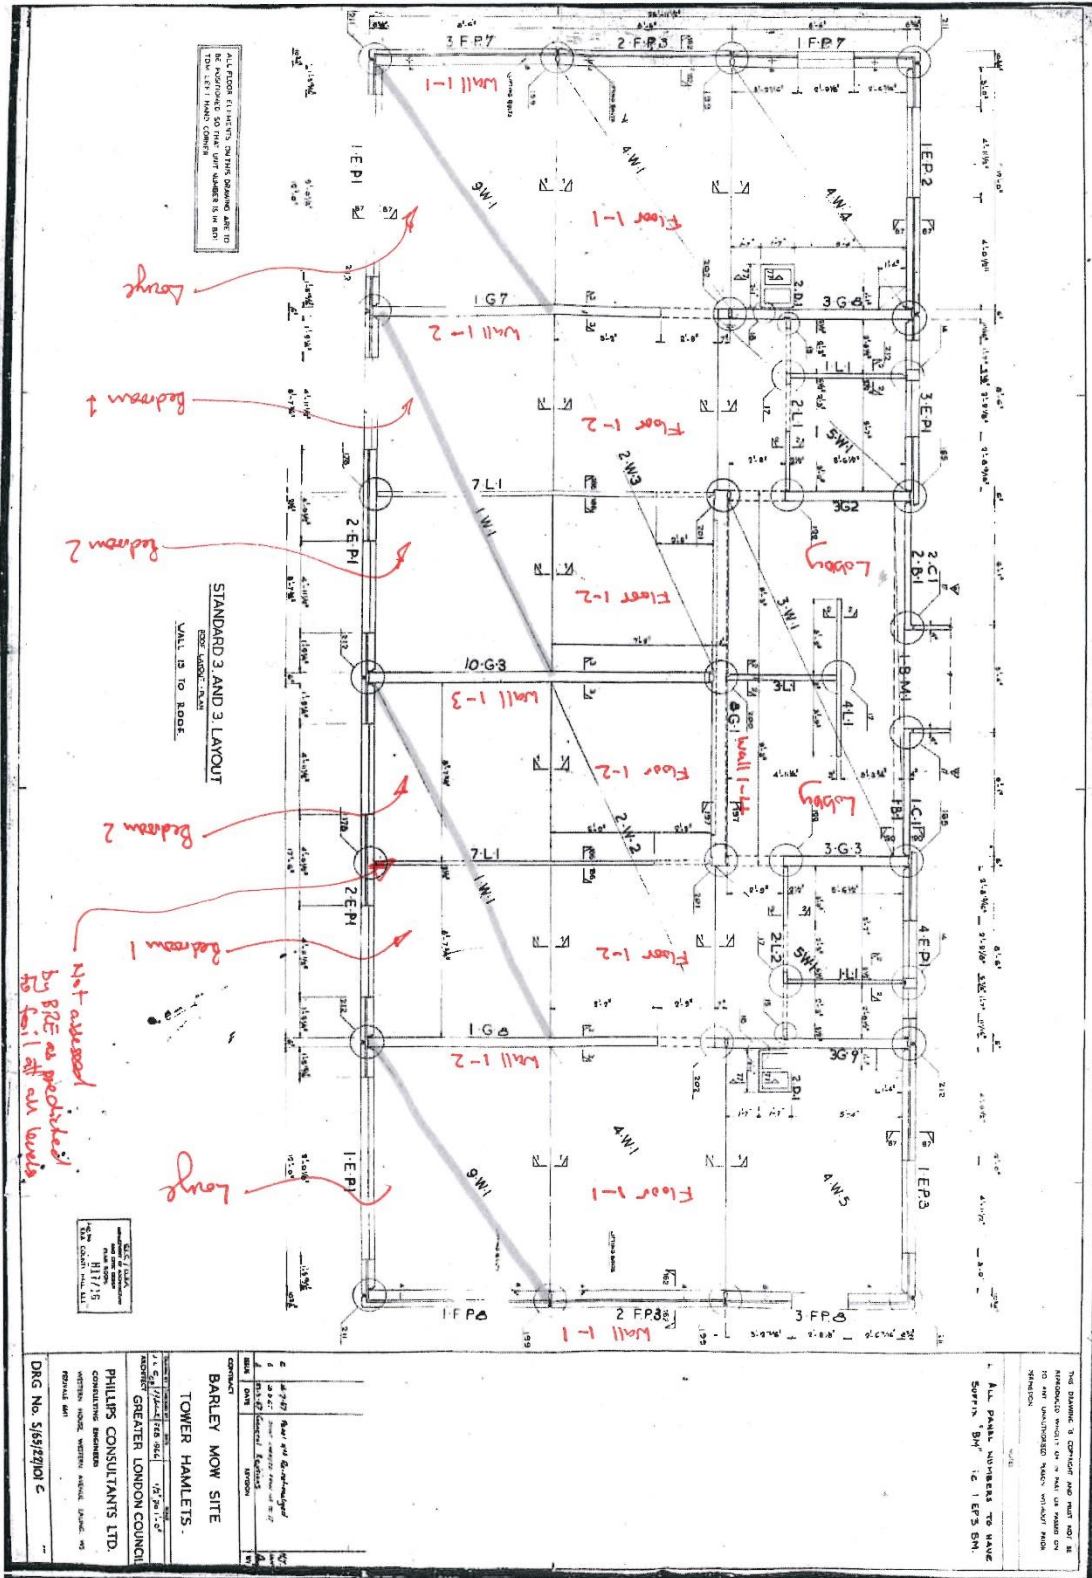
'The accompanying figure shows the locations of the various wall and floor 'Types'.

Likely to be able to accommodate the upward loading associated with 17 kN/m<sup>2</sup> flexural criterion, albeit being slightly overloaded (factor of 1.1) – dead-weight of slab/screed acting against the upward overload. However, it is calculated to be grossly overloaded (factor of 3)) in downward flexure due to the presence of a small provision of tension steel and the additional dead weight of the slab/screed acting with the downward overload pressure.

If we assume that the thin partition between the bedrooms in the storeys immediately above and below the site of an explosion can accommodate the vertical compressive loading being imparted by the 5.35 m long floor slab as it moves upwards/downwards (Robert has previously calculated that this partition can carry the vertical load without 'buckling'), then we might assume that the floor slabs above/below a bedroom is/are working as a half-span. In other words it can be assumed that the bedroom floor slabs have an effective span of 2.675 m and act accordingly. Therefore on this basis we predict that the slabs should be able to accommodate the overpressure in both upward and downward flexure.

The simplified calcs indicate that all wall types are at increased risk of base shear failure (sliding) on the top two storeys but in practice (based upon our load tests) we anticipate that only the walls on the top storey maybe at an increased risk of base shear failure. Of course in practice the strengthening steelwork is expected to prevent such a failure from occurring.

Wall Types 1-1 to 1-3 fail the assessment criterion for flexure on the top two storeys. In practice, however, we anticipate that only these wall types on the top storey will be at an increased risk of flexural failure.

Wall Type 1-4 (shear wall) meets the assessment criterion for flexure at all floor levels and should therefore be able to survive the over-pressure loading associated with a severe non-piped gas explosion.
