# Middlesex Street Area Shopfront Improvements Feasibility Stage Estimated Works and Costings Upper level Improvement Works

Issue: Feasibility V1 Date: 19.10.2020

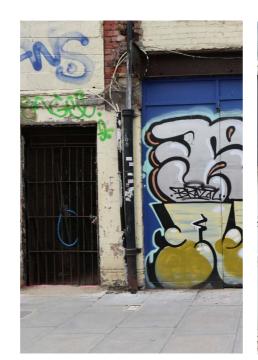
No.1 Leyden Street Rainwater pipe from building above drains into large foul pipe

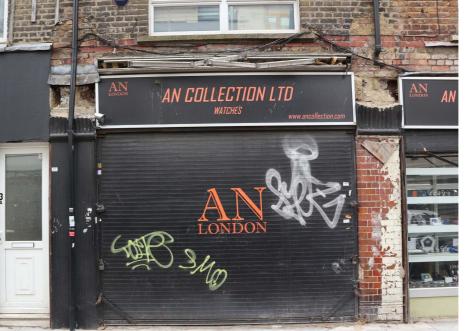
Nos.5–7 Leyden Street Inconsistent drainage layout - in front of corbel on the left and behind on the right

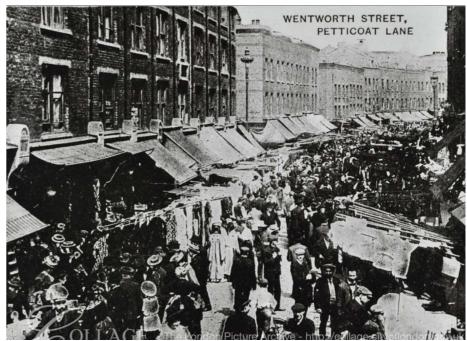
Nos.1–19 Wentworth Street Historic photograph from 1900s showing traditional position of downpipes, running along party wall between each building

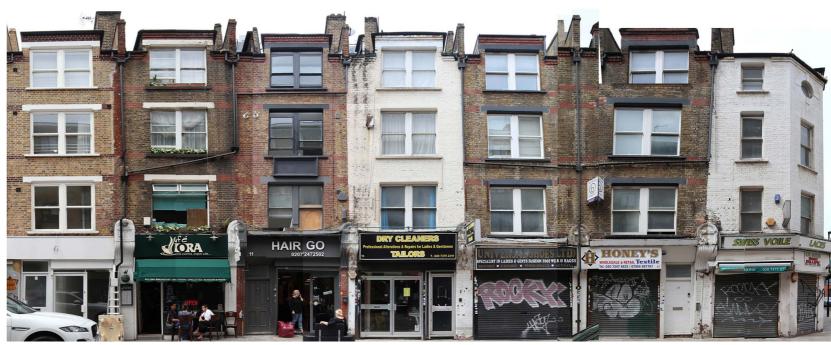
Nos.7–19 Wentworth Street Existing condition of facade drainage

Sketch 1: Proposed bespoke hopper above shopfront corbel

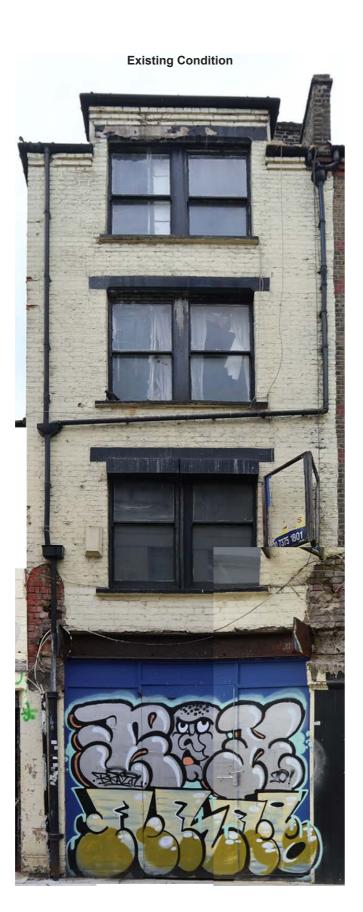
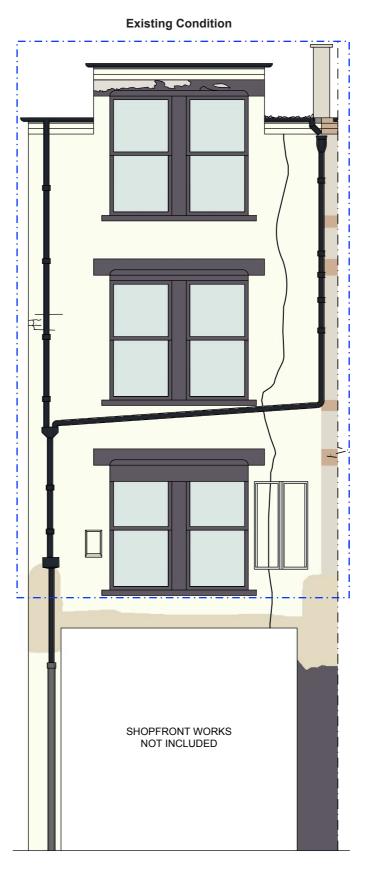
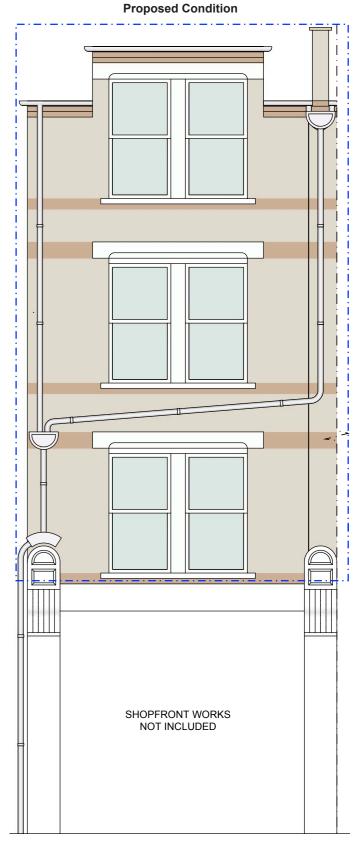
#### 1.6 Elevation Studies - 1 Leyden Street

- Architectural details damaged, loss of traditional corbels.
- Loose and peeling paintwork to entire elevation.
- Damaged windows.
- Untidy drainage across elevation, brackets unevenly spaced and multiple hoppers.
- Vegetation growing in gutters.
- Untidy cables.
- Redundant signage and fittings.

Note: Corbels removed since 2014 (Google street view)

- Redundant signage removed.
- Masonry cleaned and repaired to reveal existing brick detailing.
- Architectural details such as lintels repaired.
- Existing sash windows repaired and repainted.
- New rainwater goods in simplified design, including bespoke hoppers around reinstated corbels
- Necessary cables fixed back to elevation in neat vertical lines.
- Corbels reinstated.
