## EXECUTIVE SUMMARY

# APPENDIX A - PRICE & MYERS STRUCTURAL REPORT

### Structural Inspection Report

Price & Myers visited St George's Leisure Centre on behalf of The Turks Head Charity (client) on 14<sup>th</sup> March, 2022. The purpose of the inspection was to review the current condition of the existing building, and to advise on its suitability for refurbishment. The areas of the building considered to be of most 'concern' were inspected. No finishes were removed, no floorboards were lifted, and no intrusive assessments were carried out. As structural engineers we are unable to advise on issues related to water ingress and building services unless there are obvious structural implications.

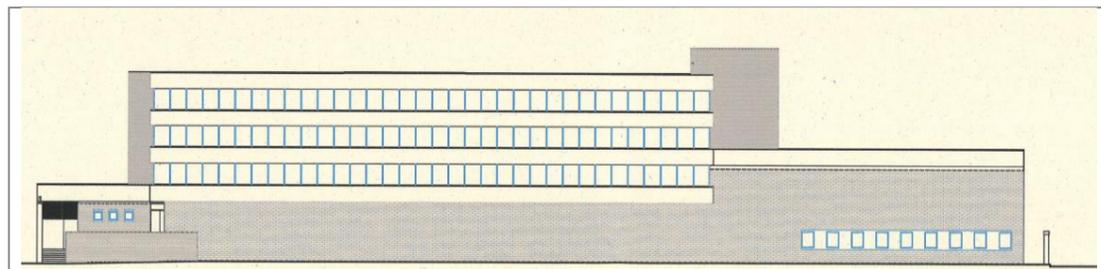
Figure 1 - Building elevation from street level, lifted from Chamberlain Consulting LLP report of 2018.

At ground to first floor, the external envelope is brick. Stretcher bond coursing is noted, suggesting the external wall is of cavity-construction. Above ground floor, the main pool hall elevations have continuous band windows with reinforced concrete upstand spandrel walls. Externally, these are faced with mosaic tiles and internally lined with woodwool slabs. The single storey section of the building containing the small pool is brickwork with isolated windows.

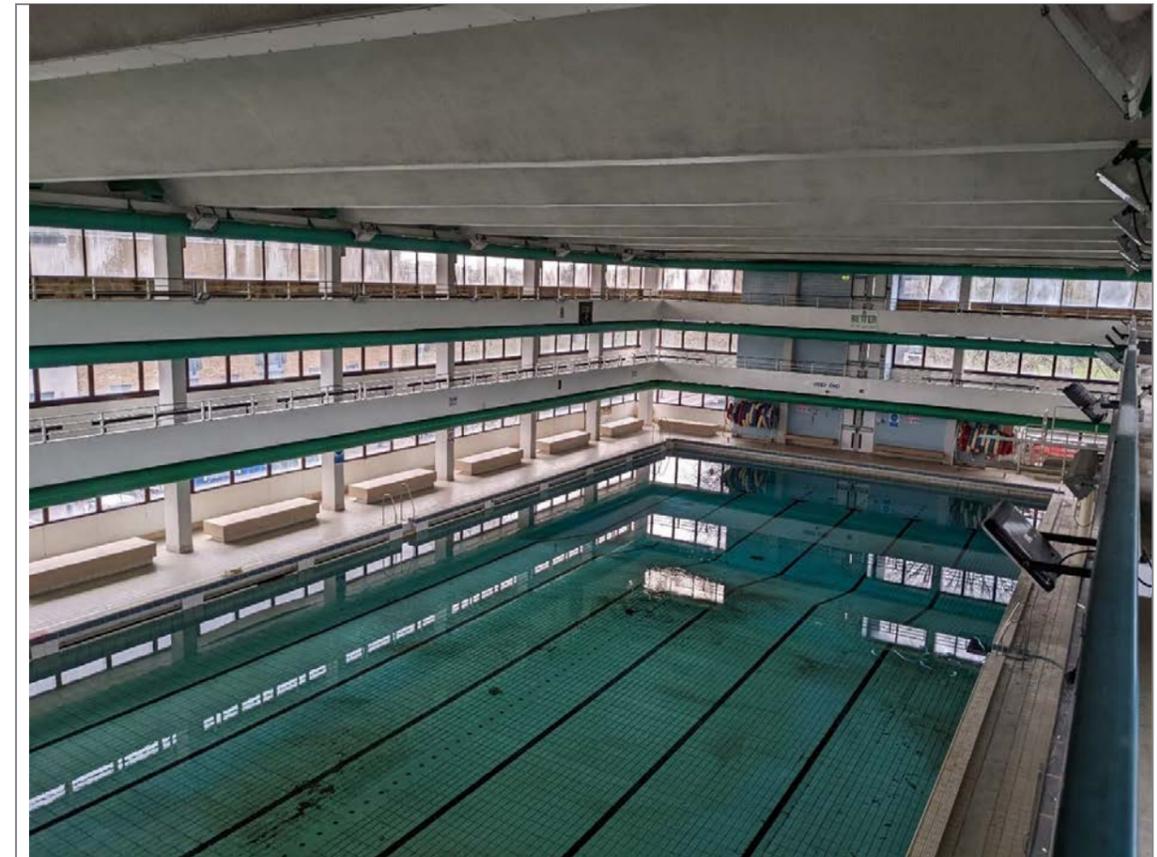
Figure 6 - main pool hall

The main pool side floor area was found to be in fair condition. Structurally, there is not much to comment on, with all primary structural members effectively covered behind finishes. Some tiles were found to be cracked with individual 'shedding' of tiles evident. Cracked and lifted tiles were also seen in the pool.

The areas where the various finishes had failed was not consistent and so not thought to be part of a wider structural frame issue. More likely over time, chlorinated, or relatively damp conditions, have combined with stagnant water ingress to cause local failure of the finishes and/or backing mortar.

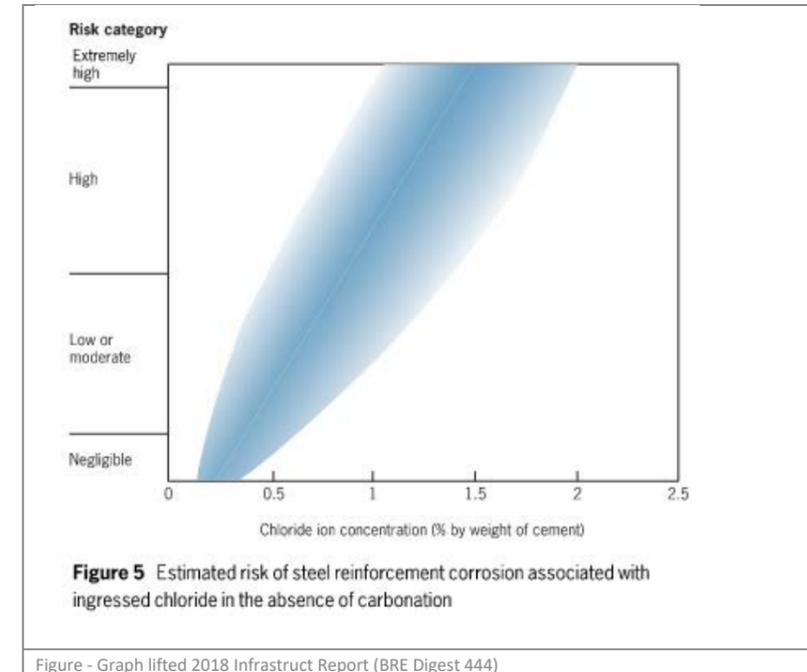
Figure - Graph lifted 2018 Infrastruct Report (BRE Digest 444)

The 2018 Infrastruct Report includes, as its figure 6, the above Figure 5 from BRE Digest 444. From this it can be seen the risk of chloride corrosion is expected to be low or negligible within the upper areas of the building where chloride content is low with only two measured concentrations of 0.27%. However it also makes clear that for the lower areas of the pool where testing was carried out in the early 2000s the risk of corrosion is likely to be at least moderate and potentially high.
