London Borough of Tower Hamlets

Malting and Brewster House

Review of Structural Assessment and
Proposed works

Issue 1 | 11 February 2020

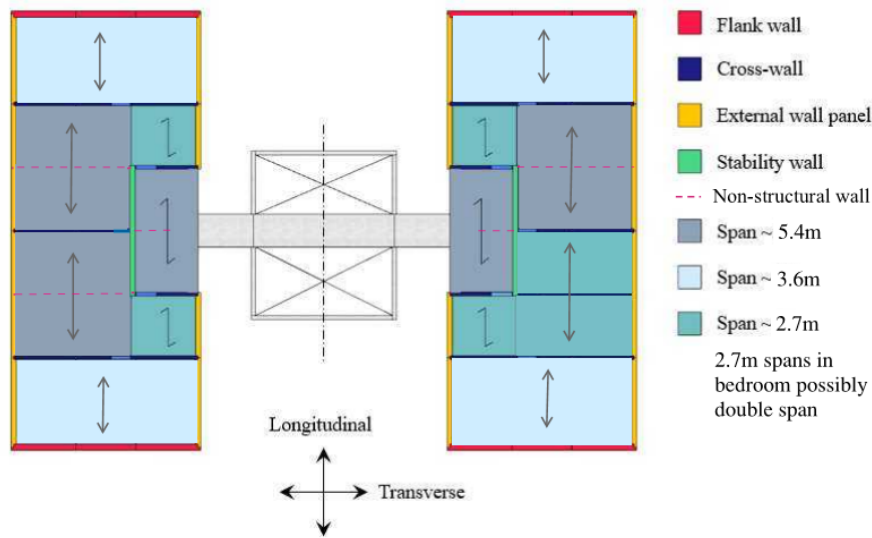
The approximate floor plan of one residential block can be seen in Figure 1. Floor slab panels are coloured according to their span length.

Lateral stability against wind loading on the broad face is provided by the cross and flank walls. Lateral stability against wind loading on the narrow face is provided by the single shear wall (shown as green stability wall) with the cross walls providing torsional resistance.

Figure 1 - Approximate floorplan of each block, illustrating the clear span dimensions..

Malting and Brewster Houses are both 14 storeys high (above podium), with a floor to floor height of approximately 2.7m (Figure 1). Each block has a ‘H-shaped’ floorplan consisting of two residential towers and a lift/stair core in-between the two towers which provides access to the towers. It is likely that each of these three structures was designed to resist wind loading independently. Floor plans vary slightly between one, two and three-bedroom flats.
